### REVISTA DE GESTÃO AMBIENTAL E SUSTENTABILIDADE - GeAS

# Multidisciplinary investigation of tree falling risk: a case study of Pau-Ferro, in São Paulo City / SP

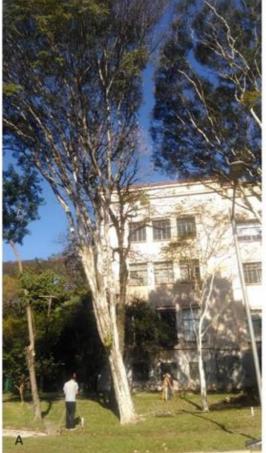
#### Figure 1

IPT has an urban forest management plan on its campus and this tree was diagnosed with an apparent cavity and trunk inclination - a fact rarely observed empirically in trees of this species, and therefore the need for specific monitoring, especially due to the fact that its eventual fall would reach the *Professor Almeida Prado* Avenue, a high-density traffic avenue and the main connection to the University of São Paulo bus terminal.

(A): Picture of the ironwood tree located in the garden of the Adriano Marchini Building - IPT, at the USP main campus in São Paulo City; and (B): Location of the pau-ferro in relation to local roads, with a tendency to tip over towards Prof. Almeida Prado Avenue

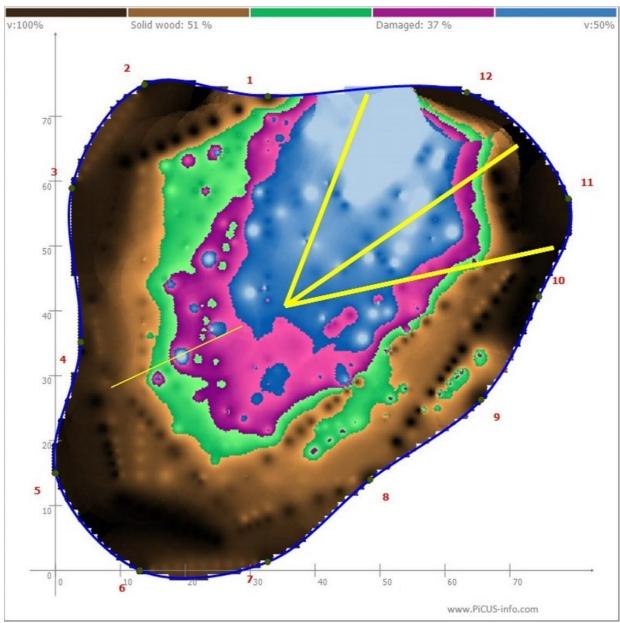
#### Figure 5

deterioration in the trunk region. In Figure 5, the cavity located between points 3 and 4, did not appear in the tomography probably because it was performed above this region.

Tomographic image of the cross-section of the trunk region. The numbers on the X and Y axes indicate the approximate diameter of the analyzed section. The numbering around the geometry represents the measurement sensor points; and the yellow lines, where the wood tends to crack. The black and brown colors indicate healthy wood, with high speed of the mechanical wave; the lilac and blue colors indicate wood with intense deterioration or absence of wood (cavity), that is, low speed of the mechanical wave. The green color, wood with alteration in its mechanical properties, but still with resistance

The deterioration found in the trunk region was stable throughout the monitoring period, with little evolution, retaining its medium deterioration classification. The "1/3" rule could not be applied as the tree had an apparent cavity. The analysis of the slenderness model (H/D=19) indicated low risk, as well as the probabilistic dynamic model with a low probability of rupture, even in high winds.

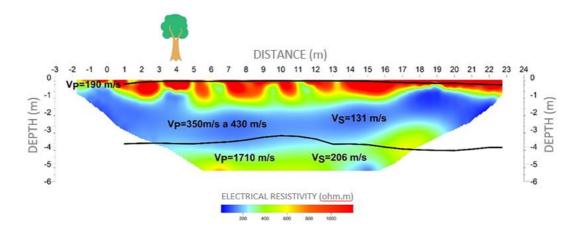
Figure 7

A shallower region with high resistivity values (warm colors) was observed, superimposed on a layer of low resistivity (shades in blue).

Modeled 2D section, with integrated results of the geophysical tests (electro resistivity, seismic refraction and MASW)

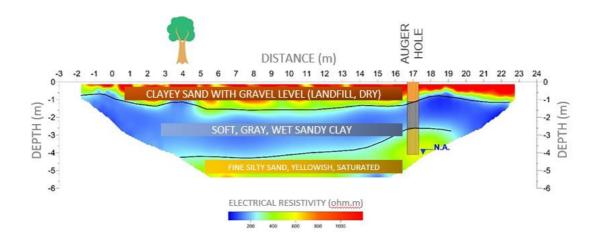
#### Figure 8

By aggregating direct information obtained from drilling the auger, a correlation between the results of the geophysical tests and the identified lithologies was established. This result is shown in the same 2D section shown in Figure 7 and the respective lithologies that occur at the site (Figure 8).

Subsurface model interpreted based on geophysical test results, (indirect) and direct information obtained with the auger hole, showing occurring lithologies in the area and their conditions in relation to water content in the subsoil

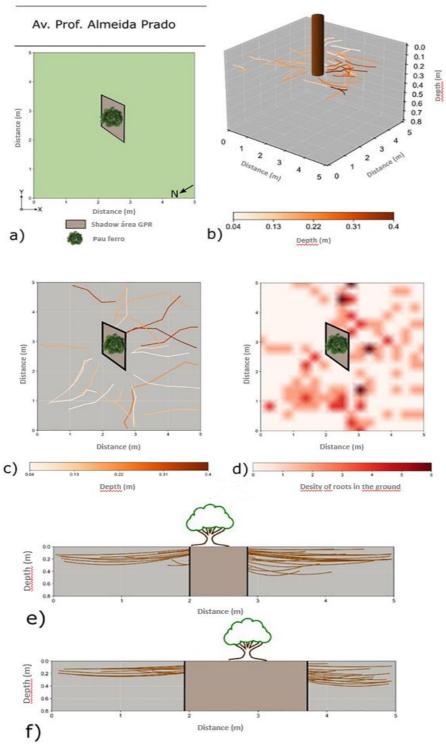
#### Figura 9

Figure 9 presents the root system obtained processed GPR data. In Figure 9a we have the schematics of the acquisition area, with the Pau Ferro tree in the center and the two acquisition directions X and Y. The maximum depth to map the roots was 0.4 m, in fine clayey sandy soil and landfill. Roots were distributed throughout the study region, and no preferential direction was observed when examined in 3D, in Figure 9b as a function of depth (2D), in the subsoil root count map and in the profiles in the two acquisition directions (Figures 9b, 9c, 9d, 9d, 9e and 9f, respectively), indicating good disposition and no barrier for development. With a resolution (minimum dimension of detection by GPR) of 3.1 cm, the diameter of the roots varied from 3.5 cm and 8.9 cm. The surface soil (up to 1.3 m) has a porosity of 23% and water content of 29%, revealing a compact and dry soil, in addition to confirming the absence of other occurrences in the soil (pipes or electrical cables), as analyzed in the available maps of the area.

Representation of the pau-ferro root system obtained by the GPR method. a) Schematic sketch of the acquisition area. b) Three-dimensional distribution of the root system. c) Spatial distribution varying with the depth of the root system. d) Map of occurrence of roots in the subsoil. e) Profile in the X direction with the distribution of the roots. f) Profile in the Y direction with the distribution of the roots

- The Ironwood has shallow roots, arranged in concentrated planes a few centimeters below the soil surface and is thus susceptible to eventual interference and deformability of the surface layer of the soil;
- The local subsoil has a surface layer of landfill, in which the Ironwood roots are found, overlying highly compressible, saturated soil, subject to settlements when subjected to increased loads;
- Vertical surface displacements evolve slowly over time, as well as the inclination of the Pau Ferro trunk;
- The inclination of the trunk changes the eccentricity of the crown and allows the change of the axis of gravity, favoring the fall;
- Despite the apparent cavity in the trunk, concentrations of roots were found in this area.

Although the Pau Ferro tree has an established root system, objective evidence of a risk of falling was found due to the evolution of surface settlement - that is, the bulging of the surface of the ground around the tree, and the consequent inclination of the trunk towards the Professor Almeida Prado Avenue, a street with high traffic volume. In view of the above, the removal of the tree was recommended.
